**Krzysztof DRAGON, Józef GÓRSKI**

## **THE INFLUENCE OF THE LAND RECLAMATION DRAINAGE SYSTEMS ON GROUNDWATER QUALITY**

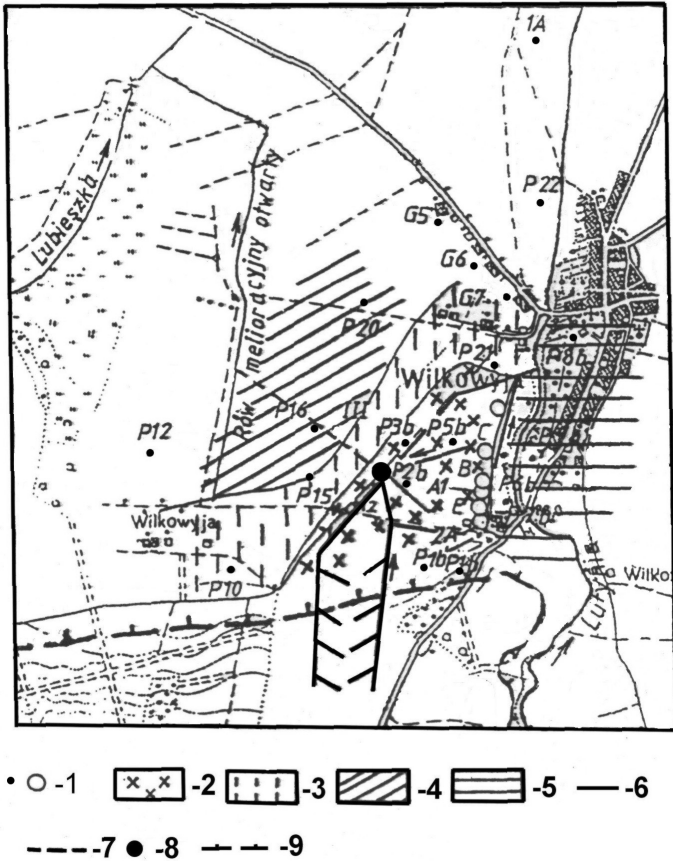
The Wilkowyja well-field is located within the area of the zerkowsko-rydzynska ice-marginal valley. The wells are located in a line barrier parallel to the Lutynia River, close to a moraine upland area boundary (Fig. 1). The thickness of the unconfined aquifer is about 20 m. The anthropogenic contamination of groundwater was documented during period of well-field construction in 1988 (nitrate concentration - 3,5-6,0 mgN-NO<sub>3</sub>/l, nitrite concentration - 0,29-0,59 mgN-NO<sub>2</sub>/l). During well-field exploitation continuous deterioration of groundwater quality was documented. Due to this fact in 1994 hydrochemical research was performed [4]. A net of piezometers was installed and samples of groundwater were taken in the well-field recharge area. The result of this research showed that the main reason of groundwater quality deterioration was the influence of water from the upland area. These waters are characterized by high concentrations of nitrite (9,0 mgN-NO<sub>2</sub>/l) and nitrate (20 mgN-NO<sub>3</sub>/l) and a relatively low concentration of chloride (34,0 mg/l), sulphate (48,0 mg/l) and Total Dissolved Solids (TDS – 311,0 mg/l) - the concentrations typical for drainage water. These waters move from an upland area characterized by agricultural land use. Groundwater occurring in the aquifer in the area outside the drainage water plume were characterized by low concentration of nitrate (1,2 mgN-NO<sub>3</sub>/l) and nitrite (0,012 mgN-NO<sub>2</sub>/l).

The explanation of the reason of the appearance of drainage water in the well-field recharge area was enabled by an old drainage system map which was recovered. The insightful analysis of these maps indicated that on the moraine upland area the LRDS was built in 1912. This system was composed of a drains net which collected soil water and shallow groundwater. These waters were moved to a collective settler well located within the area of the ice marginal valley from where drainage water was moved by pipeline to the river (Fig. 1). It was turned out during field work that elements of this drainage system had been damaged during the construction of a housing estates. This caused infiltration of drainage water to deeper groundwater and its movement to the pumped wells.

Fig. 1. Wilkowyja well-field location map. 1 – piezometers and wells sampled for chemical analyses; 2 – the area contaminated by nitrate at high level (>10 mg-NO<sub>3</sub>/l) originating from land reclamation drainage system; 3 – the area contaminated by nitrate at high level (<10 mgN-NO<sub>3</sub>/l); 4 – the area contaminated by nitrate at low level influenced by arable lands; 5 – the area contaminated by ammonia, chloride and sulphate influenced by the rural area of Wilkowyja village; 6 – drainages; 7 – pipeline moving drainage water; 8 – collective well; 9 – the valley boundary

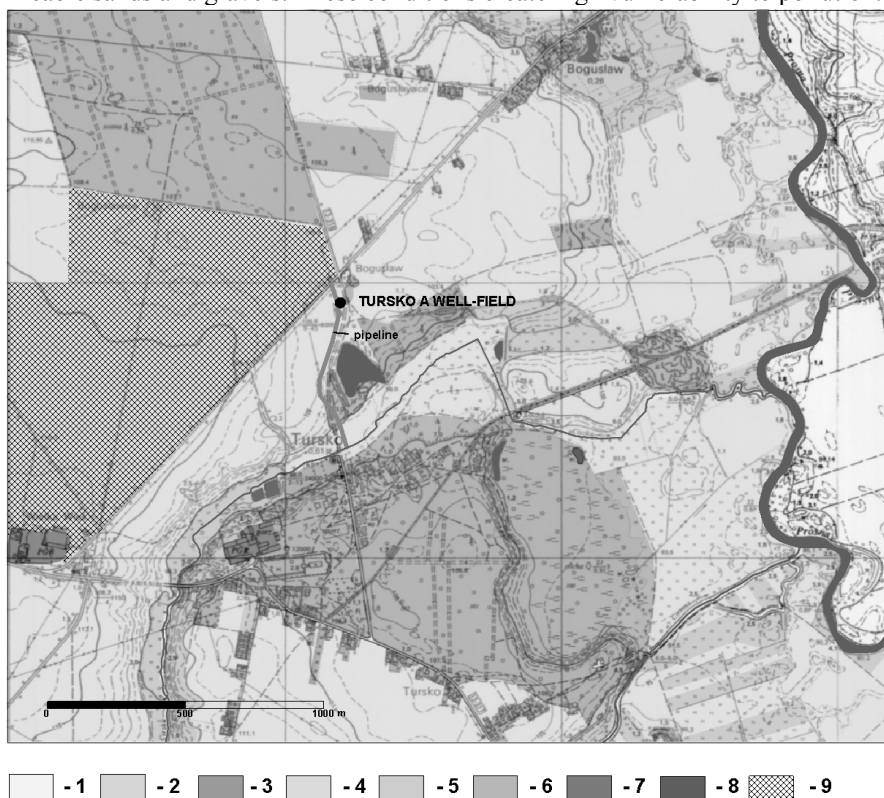
Fig. 2. Map of the land use (surrounding of the Tursko A well-field). 1 – arable lands; 2 – meadows and pastures; 3 – forests; 4 – orchards; 5 – wastelands; 6 – households buildings; 7 – animal farms (cattle and pigs); 8 – surface water; 9 – area of the land reclamation drainage system

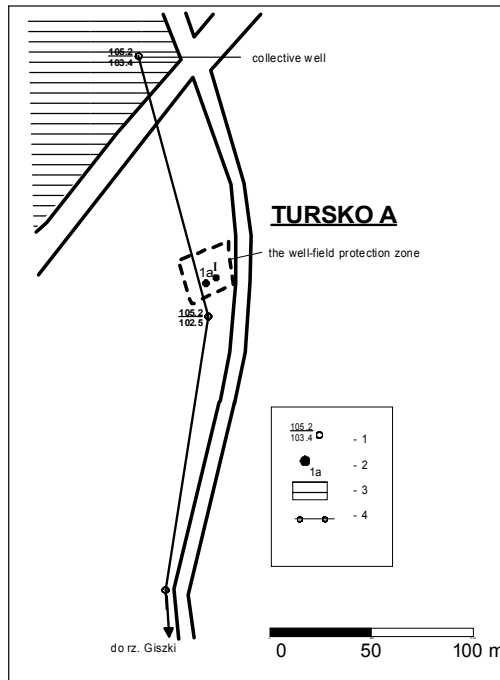
A serious source of pollution is the LRDS which functions in the surroundings of the well-field. This system is composed of a drainage net located north and north-west of the well-field (Fig. 2 and 3). Approximately 100 m north of the well-field the collective well is located from where drainage waters are moved to the Giszka stream. This pipeline is composed of cement pipes which are linked by leaking connections (unsealed). The pipeline directly crossed the well-field protection zone and is located 2 m away from

well no 1a. Moreover, the pipeline is equipped with settle wells with poorly sealed leaking bottoms. One of the settle well is located 20 m away from the well-field. Such faulty construction of the pipeline causes infiltration of drainage water directly to the ground within the wells cone of depression. Drainage water originating from agricultural cultivated fields where organic and mineral fertilizers (and also waste products from a distillery factory) are used are invariably strongly contaminated (particularly by nutrients). Moreover, these settle wells are open and not protected. As a consequence it is easy to spill sewage or manure into them.

Fig. 3. Location of the components of land reclamation drainage system nearby Tursko A well-field. 1 – settler wells; 2 – wells of the Tursko A well-field; 3 - area of the land reclamation drainage system; 4 – pipeline

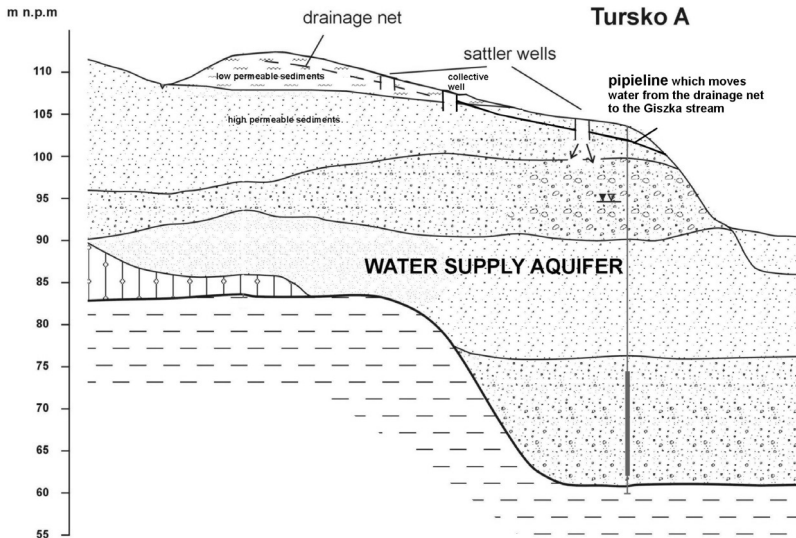
Fig. 4. The schematic hydrogeological cross-section

The most probable reason for bacterial contamination was infiltration of drainage water from the transmit pipeline directly crossing the well-field protection zone, which moves water from drainage net to the Giszka stream (Fig. 4). The transmit pipe is located 2 m away from the well no 1a. The direct reason of contamination almost certainly was damage of the transmit pipeline, that took place in January 2007, when digging work was carried out to unblock the movement of water in the pipe. This reason was documented by the differentiation of groundwater quality in two wells with identical construction, during simultaneous pumping of these two wells. The higher level of contamination in well no 1a located near to the pipeline (2 m away) than in well no I more distant from the pipeline (8 m) was observed. This is also supported by the fact that bacterial contamination appeared in 2007, while the pipeline has existed from the beginning of the well-field exploitation.
